Damage Assessment Request Procedure

Unincorporated County

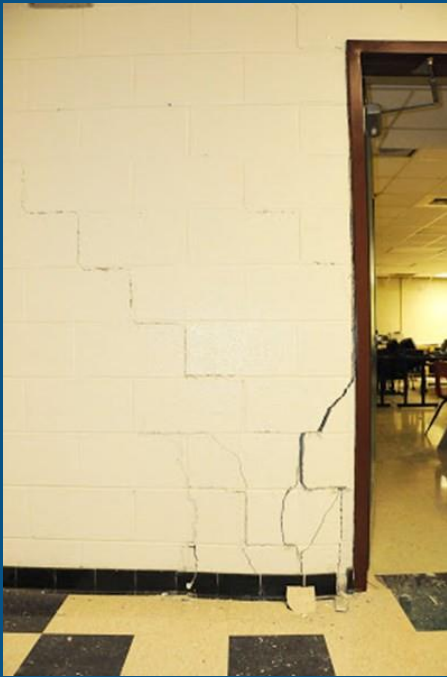
Figure 1. Stepped cracking in masonry wall with buckling and out-of-plane spalling of CMU shell at toe of wall segment.

- CMU partitions: Stepped cracking within mortar joints (Figures 1 and 2), typical in both stories, both directions. Vertical cracks adjacent to encased steel columns. Horizontal separation between CMU units in multiple locations, up to one-inch wide in four places in the north-south direction in the second story (Figure 2). Crushed, spalled or buckled masonry units (Figure 1) in four locations in the first story, at the toe of north-south wall segments.

The two other damage patterns – one-inch wide cracks and buckled or spalled units – do indicate a more fundamental change to the north-south walls' pre-earthquake condition. With the joints separated and the toe of certain wall segments starting to disintegrate, it can be reasonably judged that the damaged wall would perform in a degraded fashion under additional earthquake loading. Does this represent a 33 percent capacity loss to an entire story as the definition of SSD requires? This is a matter of judgment, and any conclusion is subject to review. For this example, it is judged that the change of state represented by the two advanced damage patterns does represent a substantial capacity loss, so **it is concluded that SSD to the lateral system has occurred** at each story in the north-south direction.

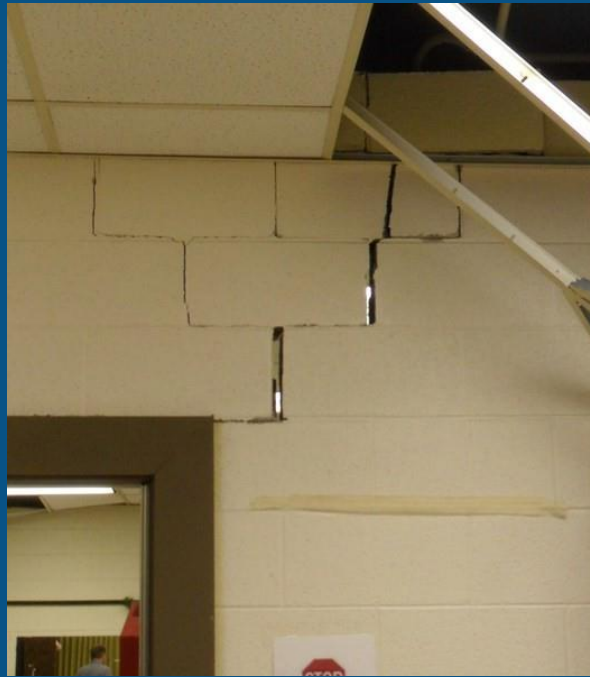
Figure 2. Stepped cracking in masonry wall with up to 1 inch horizontal separation between units.

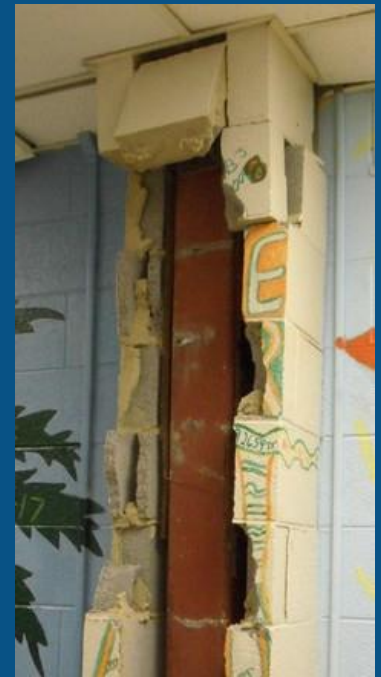
Figure 3. Damaged CMU removed, revealing undamaged steel tube column.

- Steel floor/roof framing and tube columns: No apparent damage. The frame clearly swayed, but with damaged CMU removed in a few locations (Figure 3), no member buckling, weld damage, or bolt damage was observed, and none is suspected.

SSD to the gravity system: With no apparent damage to the steel framing, and with the steel gravity system apparently unaffected in its ability to carry the existing dead and live loads, **it is concluded that SSD to the gravity system has not occurred.**

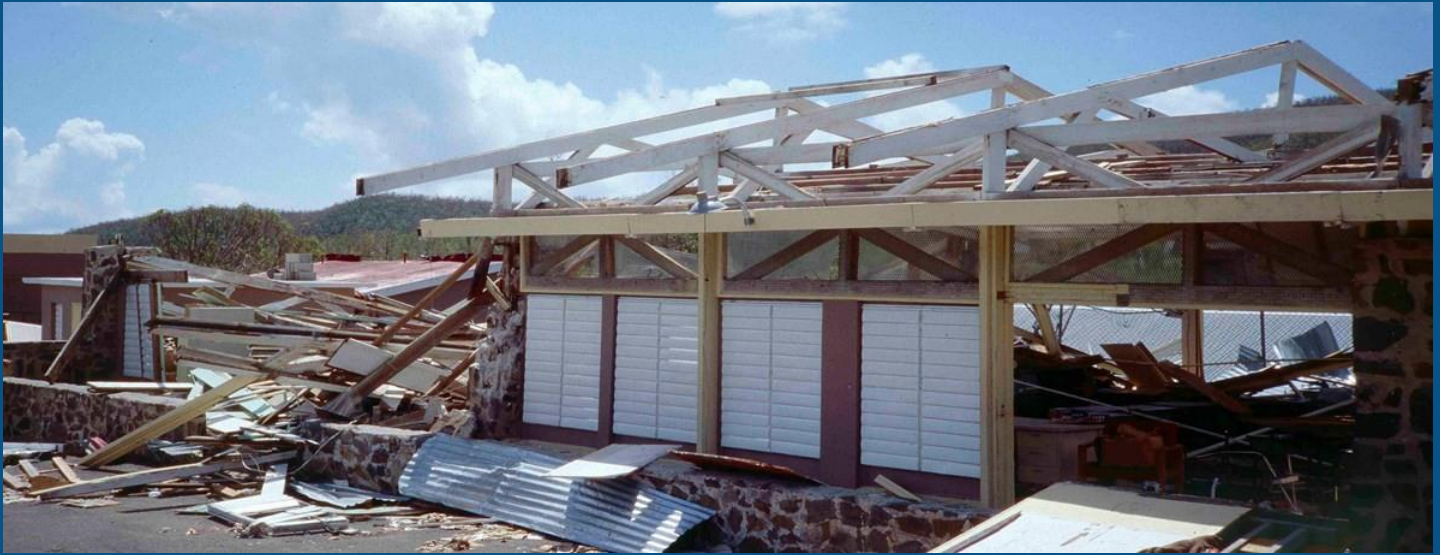
Figure 4. Two classrooms at the far end of the six-classroom building completely destroyed. Photo:FEMA

- Roof trusses: Trusses lifted and blown off over two classrooms at one end, about one third of the building footprint (Figure 4).
- Post and beam framing: Framing collapsed where the trusses blew off (Figure 4).
- Shear walls: Two short-direction shear walls collapsed at the end where the trusses blew off (Figure 4). Other short-direction walls and all long-direction walls were undamaged by wind, but there was damage due to rain through the damaged roof.
- Roof: Roof panels blown off over about four classrooms, or two thirds of the building footprint.
- Nonstructural components: Windows and shades damaged by wind-borne debris. Extensive water damage to interior finishes.
- Contents: Extensive loss due to wind and water damage.
